Manhole Inspection Summary

Manhole # S31EE_058MH

Insp Date: **1/29/07 9:19 AM**

Location Address: **311 DOLPHIN ST**

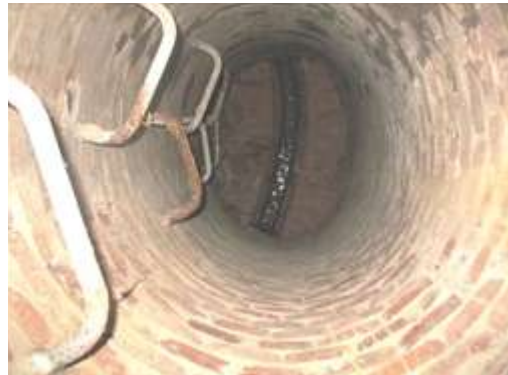
Top View

Corroded steps. Bench debris.

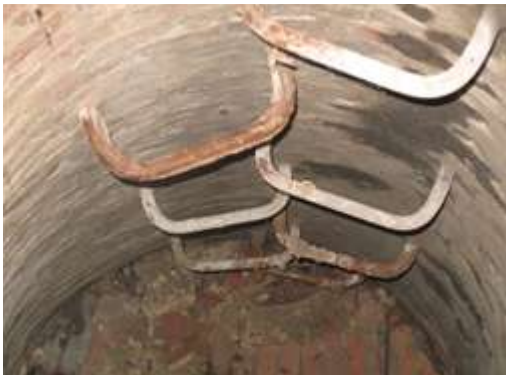
Defect

Corbel and Barrel infiltration.

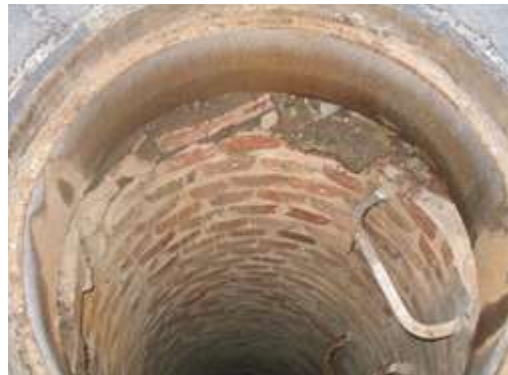
Defect

Frame leaks. Adjustment deterioration, loose brick and infiltration - other side.

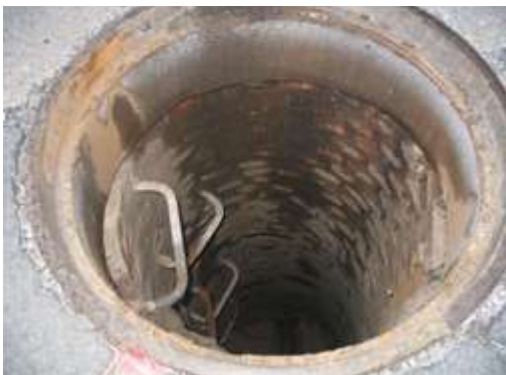
Defect

Frame leaks. Adjustment deterioration and infiltration. Corbel and Barrel infiltration.

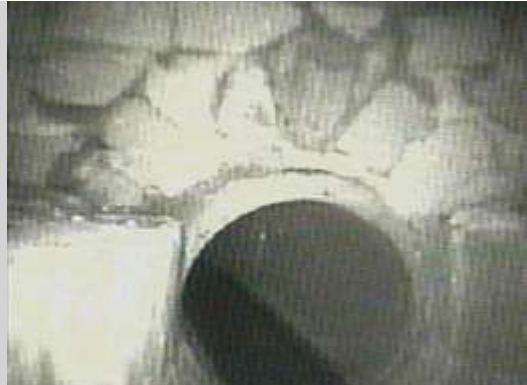
8 in. Circular Gravity Sewer Pipe Out @ 12 O'Clock

Barrel deterioration and infiltration.

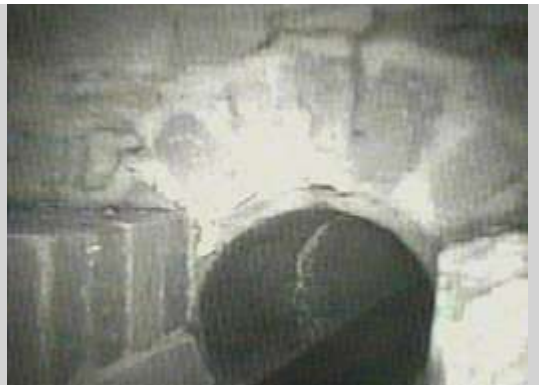
8 in. Circular Gravity Sewer Pipe In @ 7 O'Clock

Infiltration: **Evidence** Pipe Seal Cond: **Unknown**
